Gerard v. Omega Flex

March 20, 2016

Executive Summary

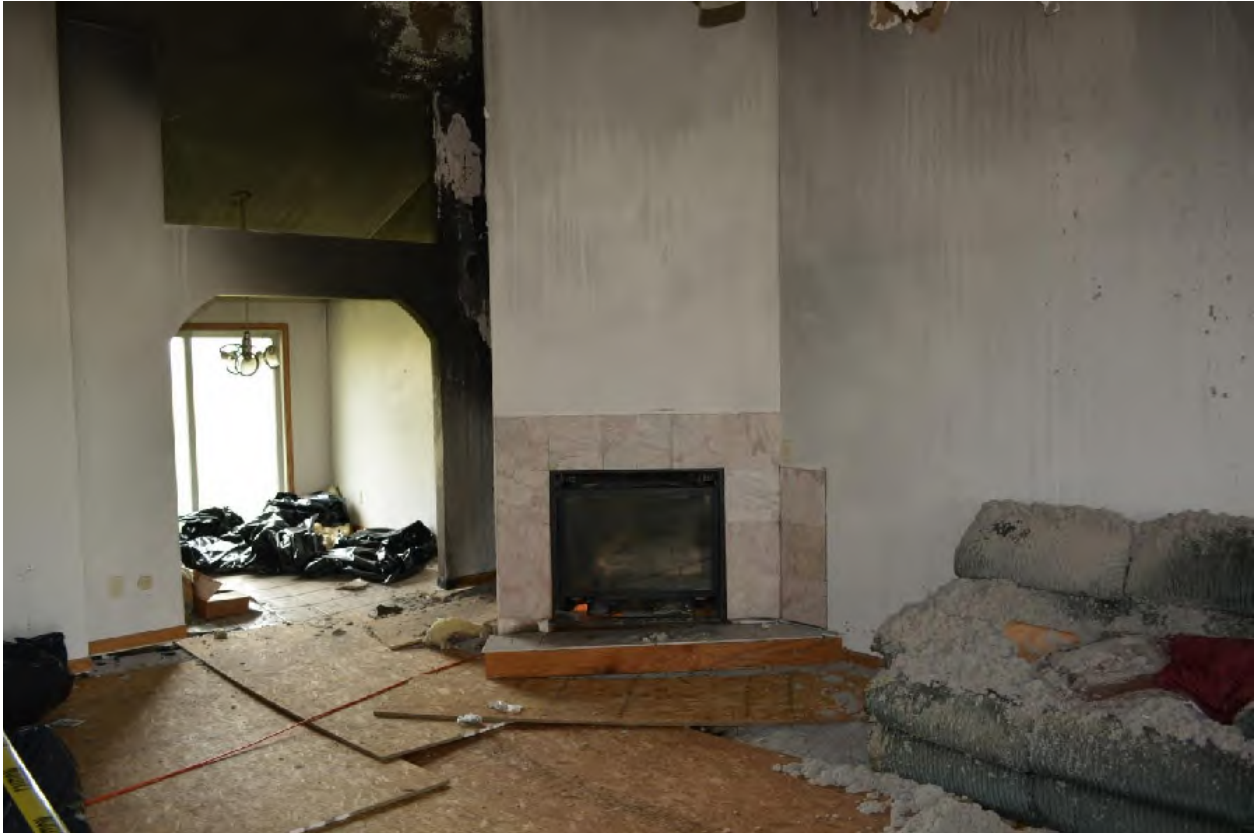
Mr. Gerard observed flames coming from the front of the base of the fireplace just after he heard the lightning strike. There was fire damage to the floor in the vicinity of the fireplace (see Figure 6 and Figure 7) and smoke damage throughout the first floor.

Figure 6. Photograph of the living room fireplace. There was fire damage to the floor in front of the fireplace, covered by oriented strand boards in the photograph.

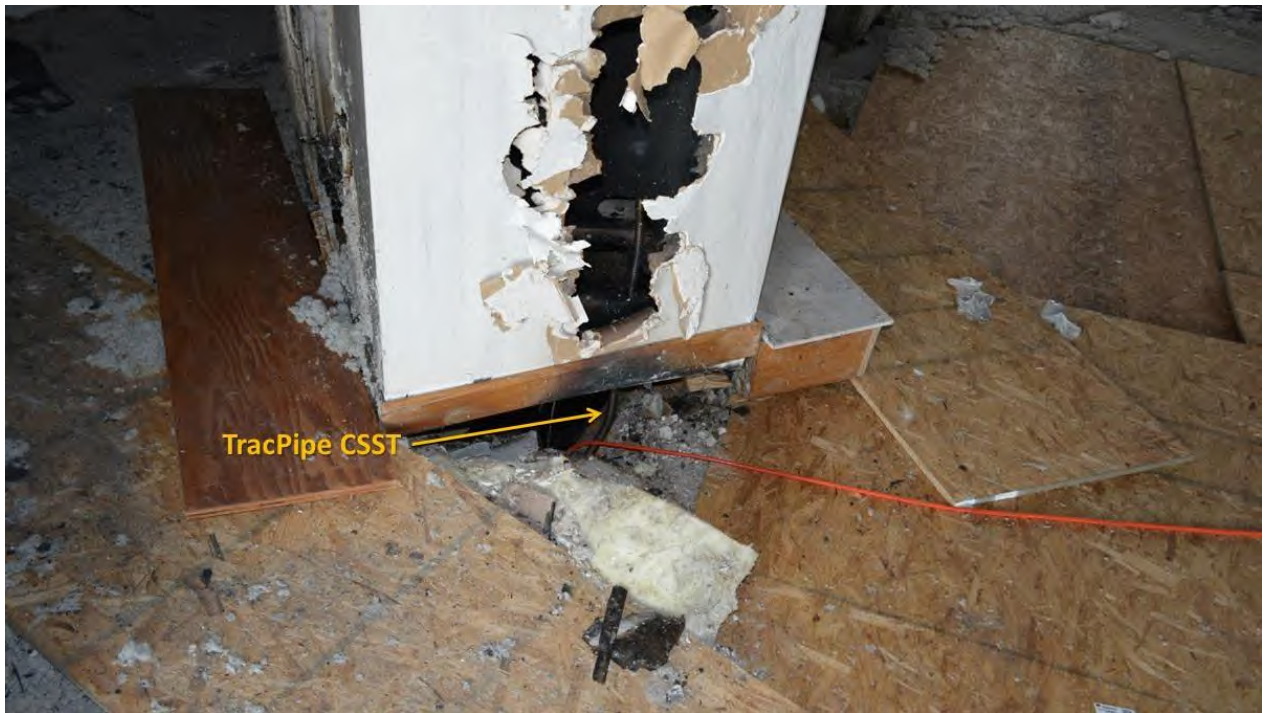
Figure 7. Photograph of the base of the living room fireplace. Fire had burned through the floor in this location. The TracPipe CSST line to the fireplace is also visible.

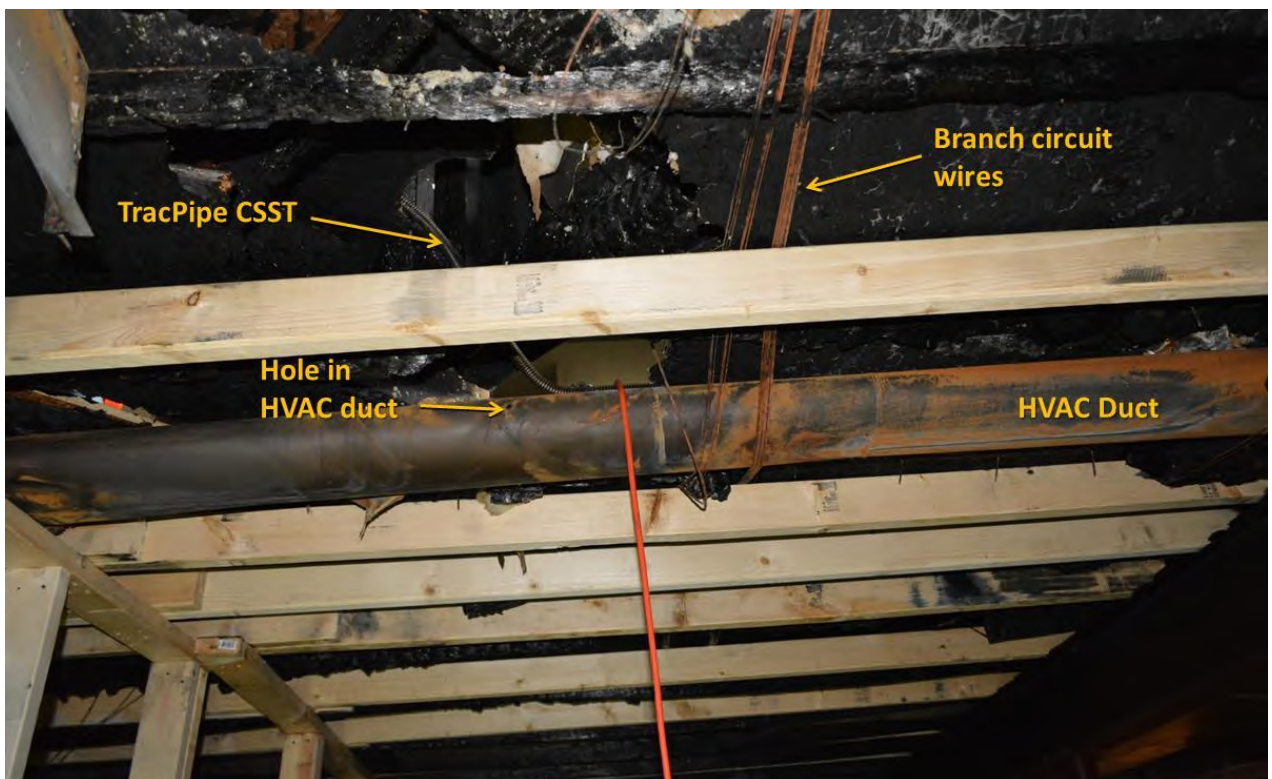
There was also fire damage in the basement, at the level of the basement ceiling, as shown in Figure 8 through Figure 10. The damage was most severe in the vicinity of the bottom of the fireplace, where floor joists had been completely consumed.

Figure 8. Photograph of the basement ceiling directly below the fireplace. The photographer is looking west. The unburned wooden members were installed for structural shoring after the fire.

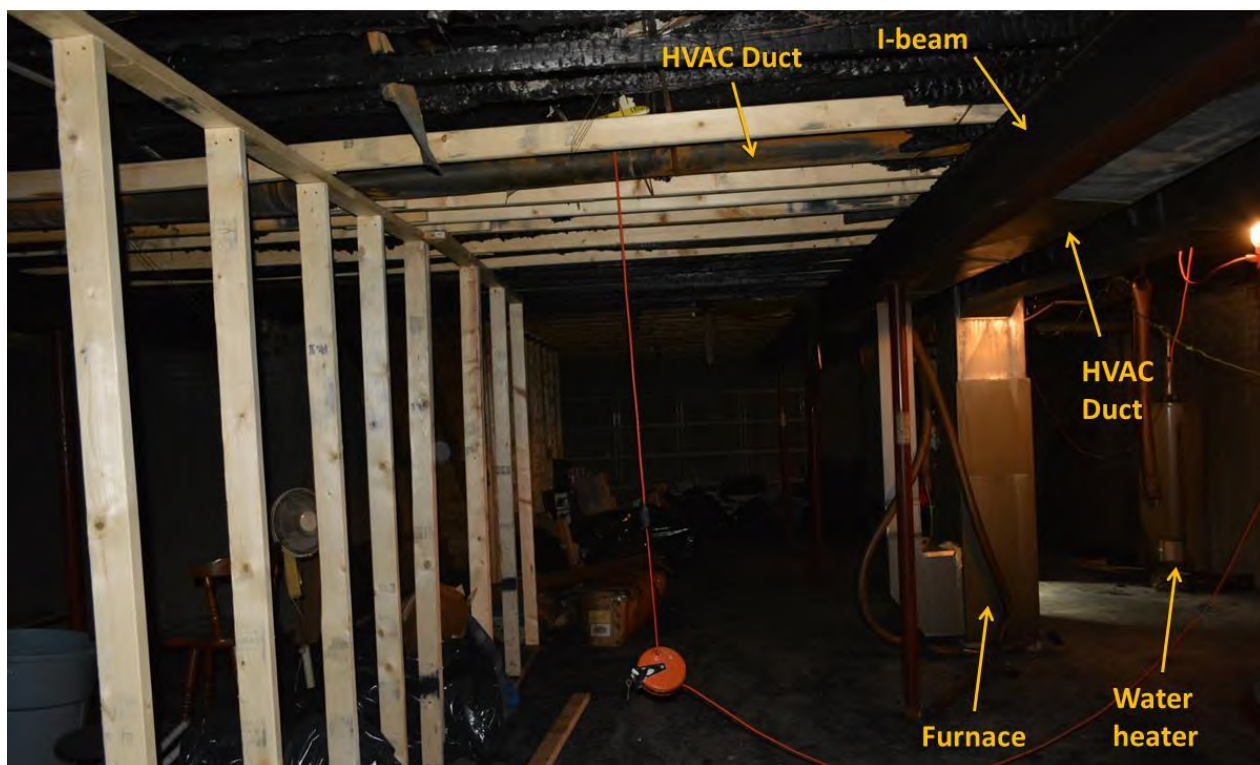
Figure 9. Photograph of the basement, looking west.

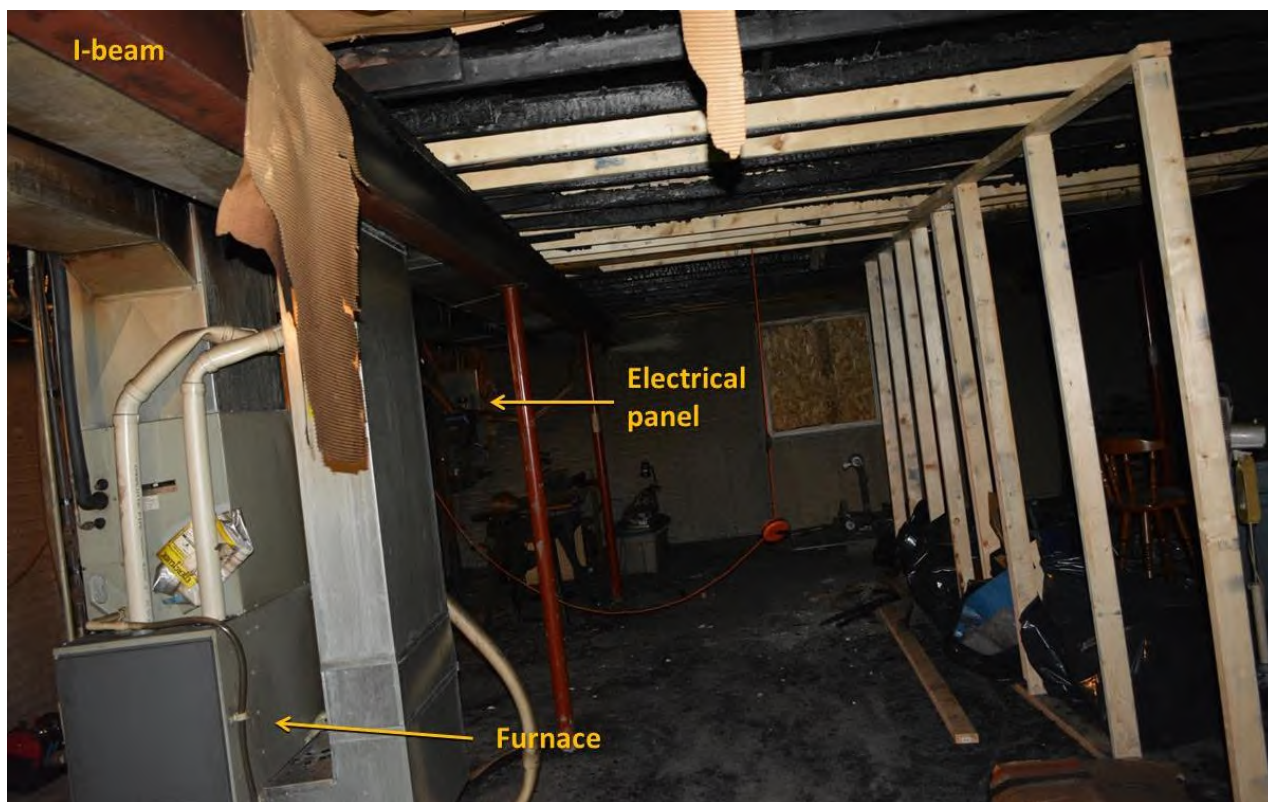
Figure 10. Photograph of the basement, looking east.

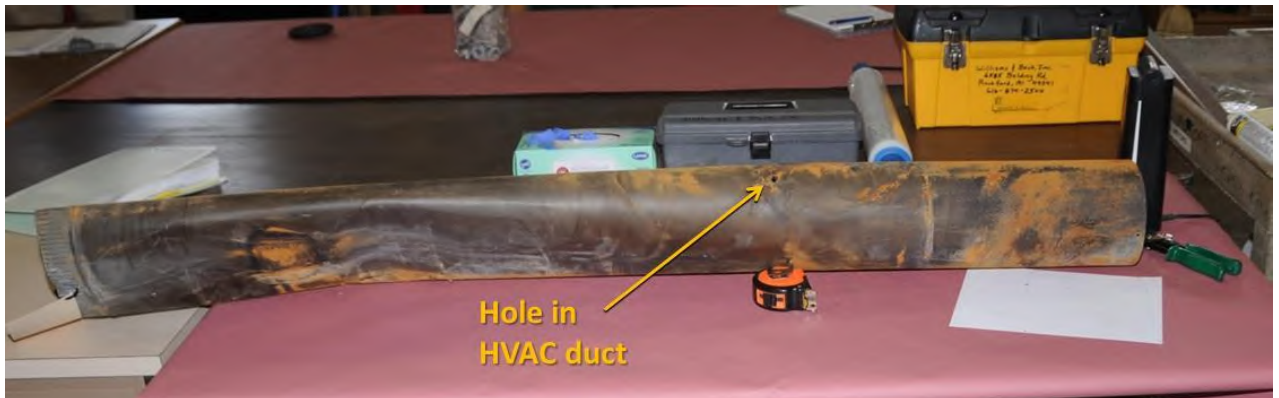
Figure 11. Photograph of the south section of the HVAC duct.

A hole was found in the south section of the HVAC duct. The location of the hole is shown above in Figure 8 and Figure 11. The hole had molten and resolidified metal around the edge (see Figure 13), indicating that it was caused by electrical arcing.

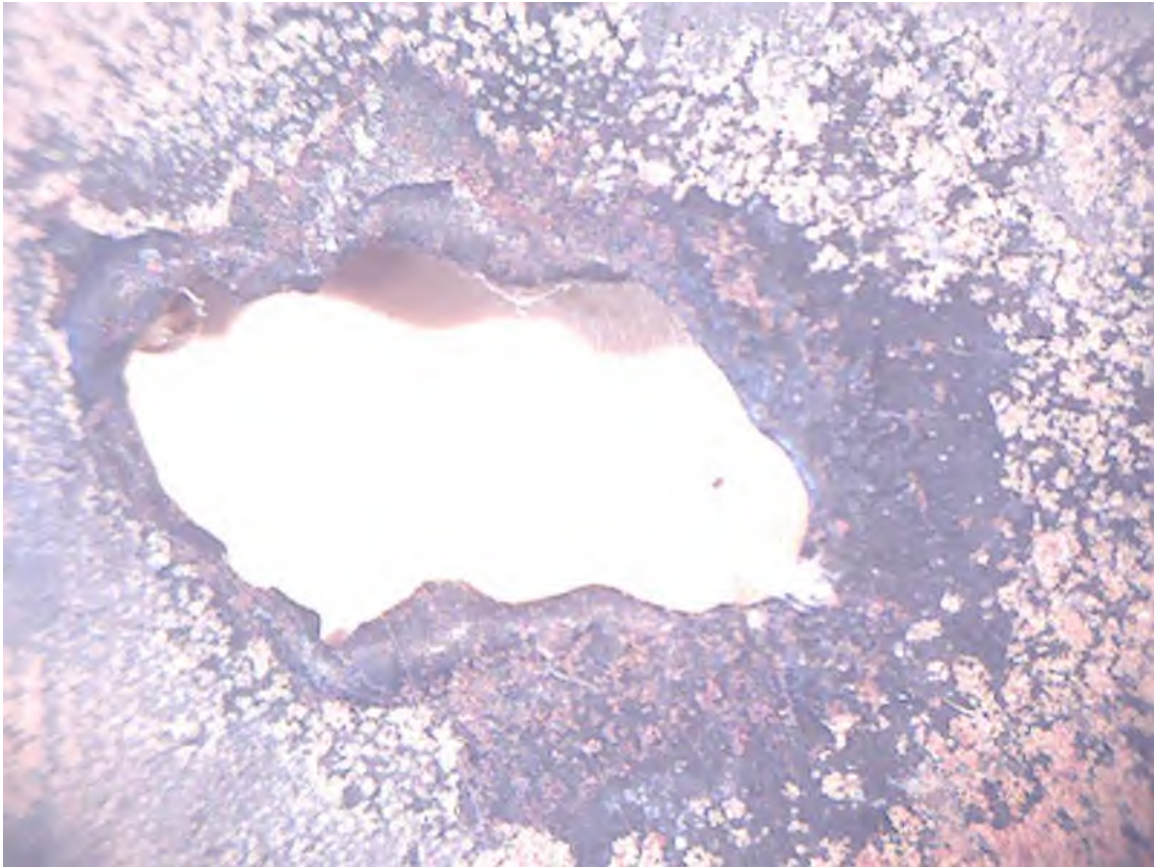
Figure 13. Optical microscope image of the hole in the HVAC duct.

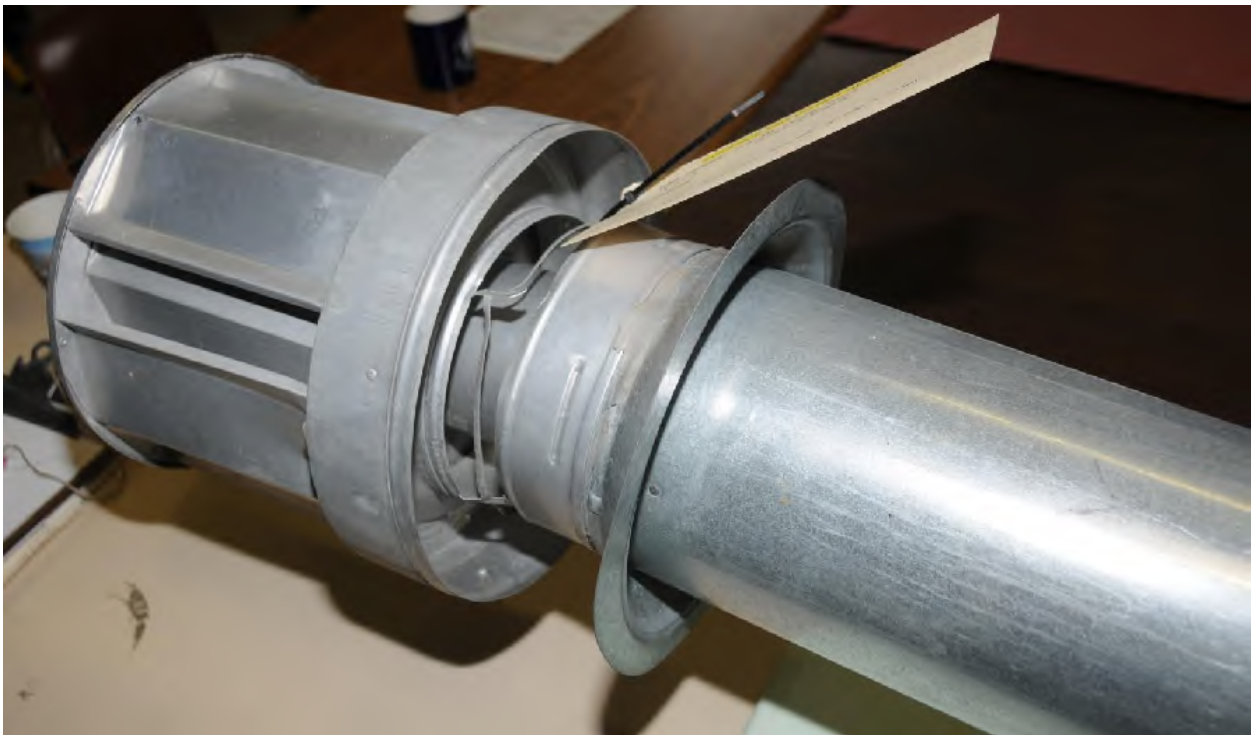
The flue pipe for the fireplace comprised multiple sections of double-walled vent piping (see Figure 14). It terminated at the top with a chimney cap (see Figure 15). There were multiple locations on the chimney cap where the metal had melted and resolidified (see Figure 16 and Figure 17). This damage indicates that lightning directly struck the flue pipe chimney cap.

Figure 15. Photograph of the chimney cap at the top of the fireplace flue piping.

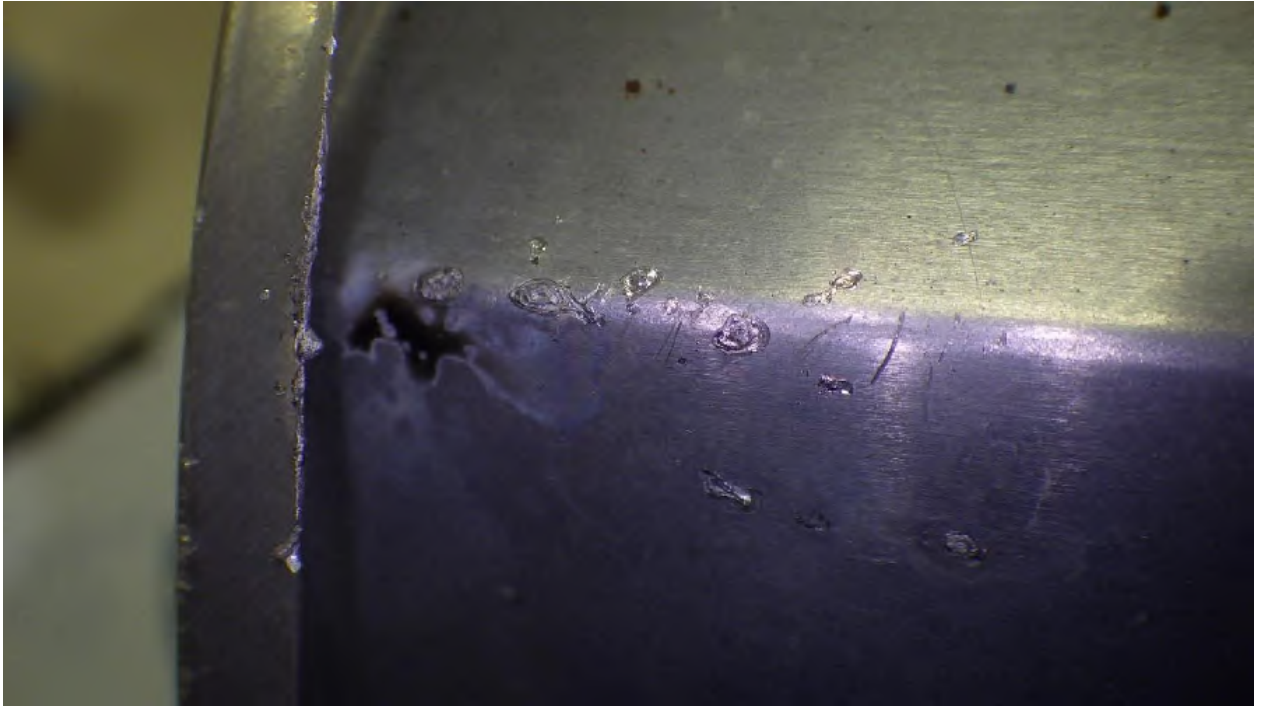
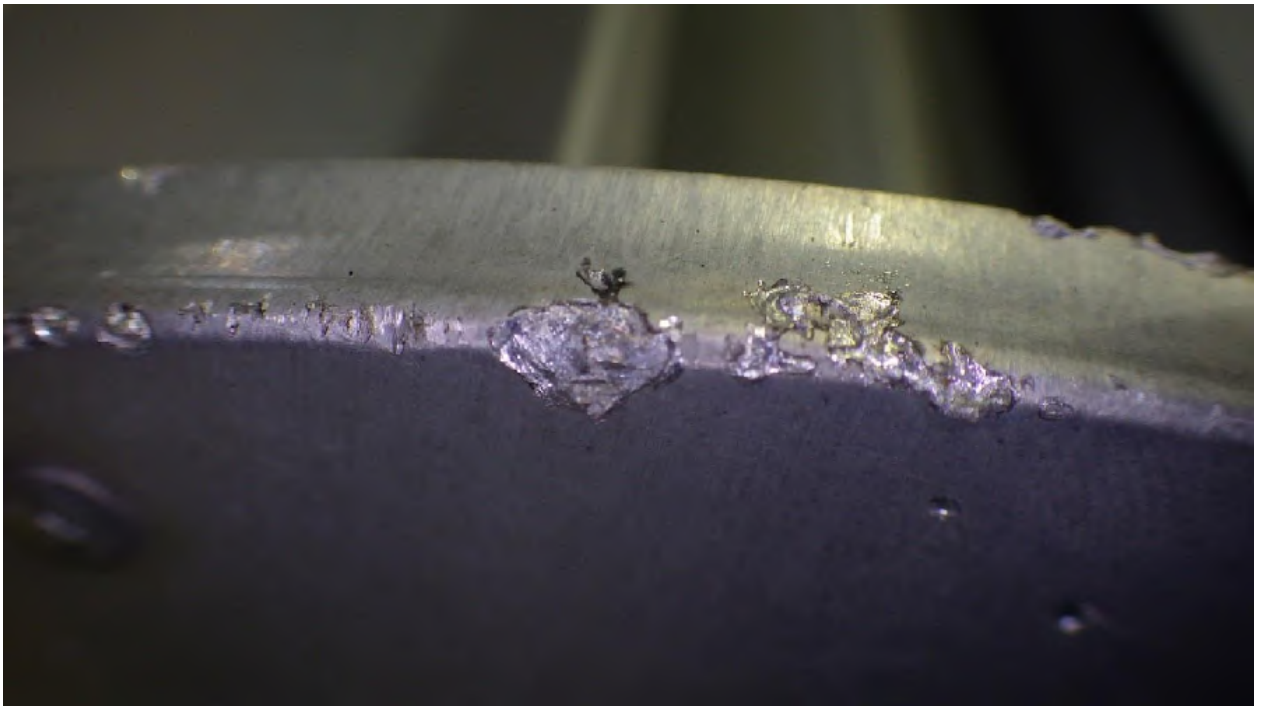
Figure 16. Example photograph of the electrical damage to the chimney cap.

Figure 17. Example photograph of the electrical damage to the chimney cap.

Mr. Hooker stated that he saw no evidence that the building was directly struck by lightning,¹⁶ and further that there was no damage to the chimney cap that is consistent with lightning.¹⁷ Mr. Hooker is incorrect. There were multiple locations on the chimney cap with molten and resolidified metal, as well as electrical damage at the seam between adjacent sections of the flue pipe. The damage to the chimney cap could only have been caused by electrical arcing, and there were no sources of electrical energy on the roof of the Gerard home that could have caused the damage other than lightning. The physical evidence unambiguously shows that the chimney cap was struck by lightning. Mr. Hooker has provided no alternative explanation of the damage.

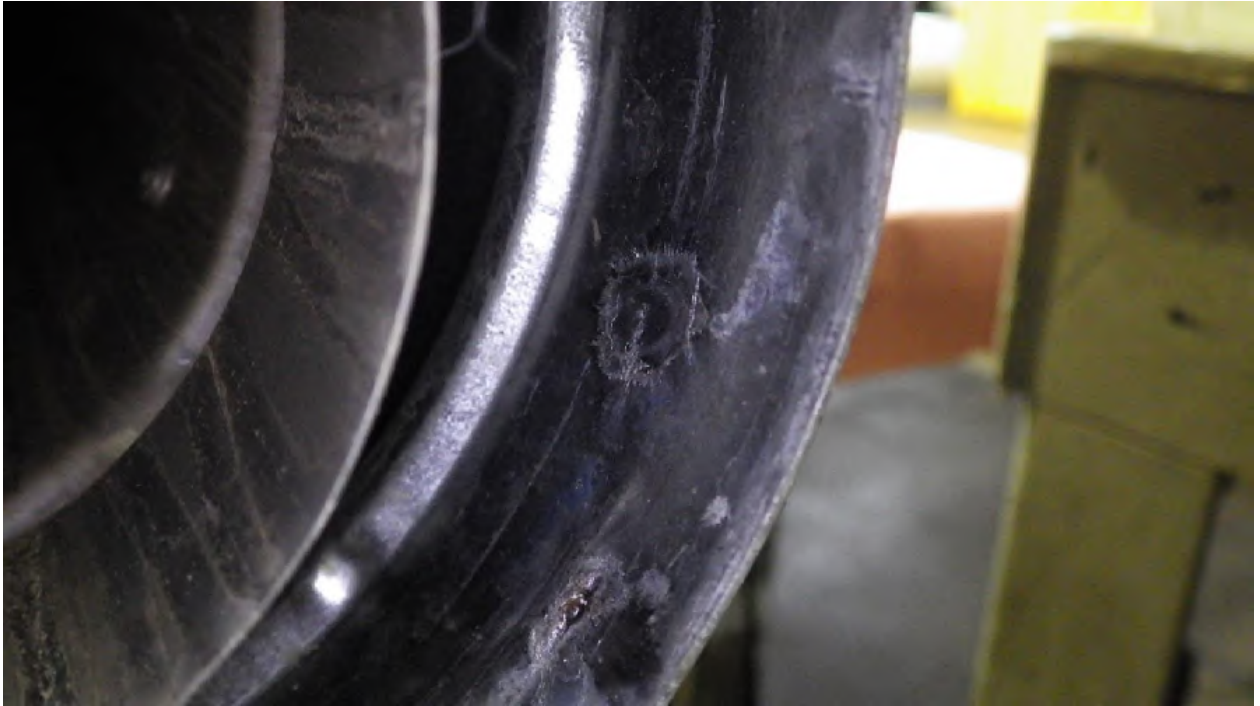
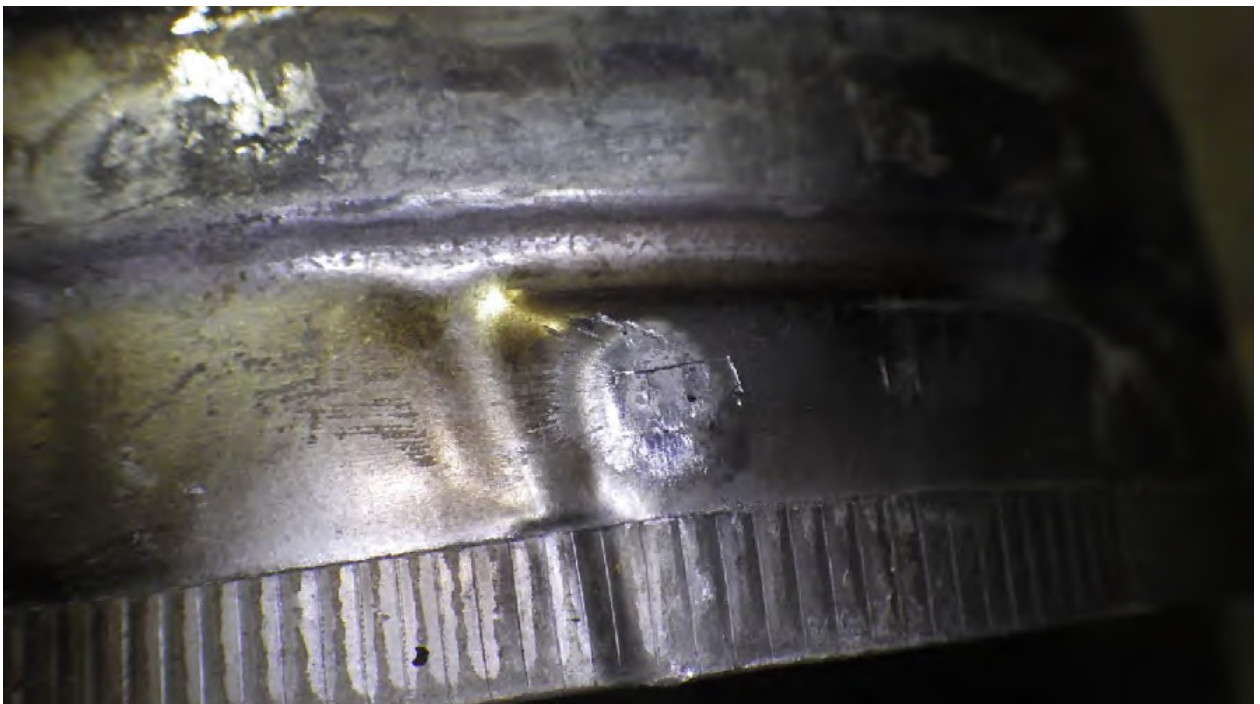
In addition to the electrical damage to the chimney cap, there was also electrical damage at the junction between adjacent sections of the flue piping, as shown in Figure 18 and Figure 19. This electrical damage is an additional indication that the flue piping was directly struck by lightning.

Figure 18. Photograph of electrical damage on the inside surface of the flue piping at a location where adjacent sections of flue piping overlapped.

Figure 19. Photograph of electrical damage on the outside of the flue piping at a location where adjacent sections of flue piping overlapped.

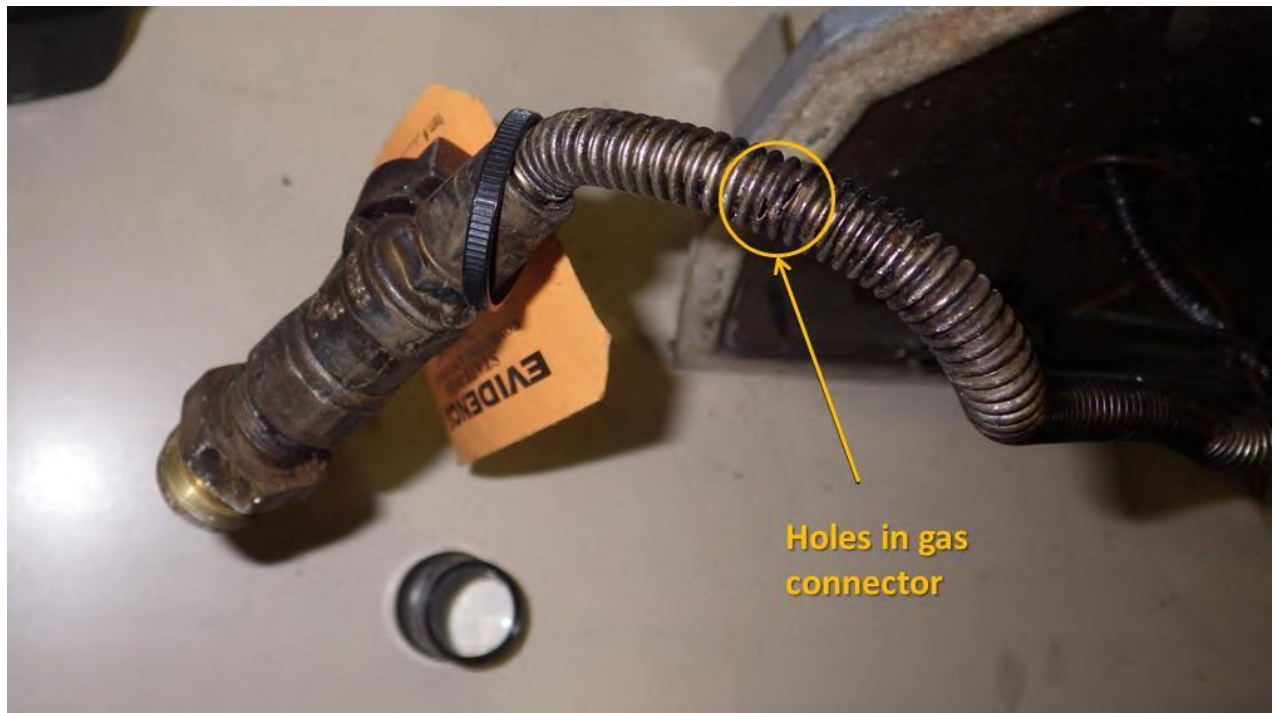
As shown above in Figure 4, the fireplace comprised two compartments, a larger main compartment and a smaller compartment underneath with a flexible gas connector and the gas valve. There were two holes in the flexible gas connector that ran from the TracPipe CSST to the gas valve in the bottom compartment of the fireplace (see Figure 20). Both holes showed molten and resolidified metal around the edges (see Figure 21), indicating that they were caused by electrical arcing. Both holes were approximately elliptical, one had dimensions of approximately 1 mm x 4 mm, while the other had dimensions of approximately 1 mm x 3 mm.

Figure 20. Photograph of the flexible gas connector to the gas valve in the lower compartment of the fireplace.

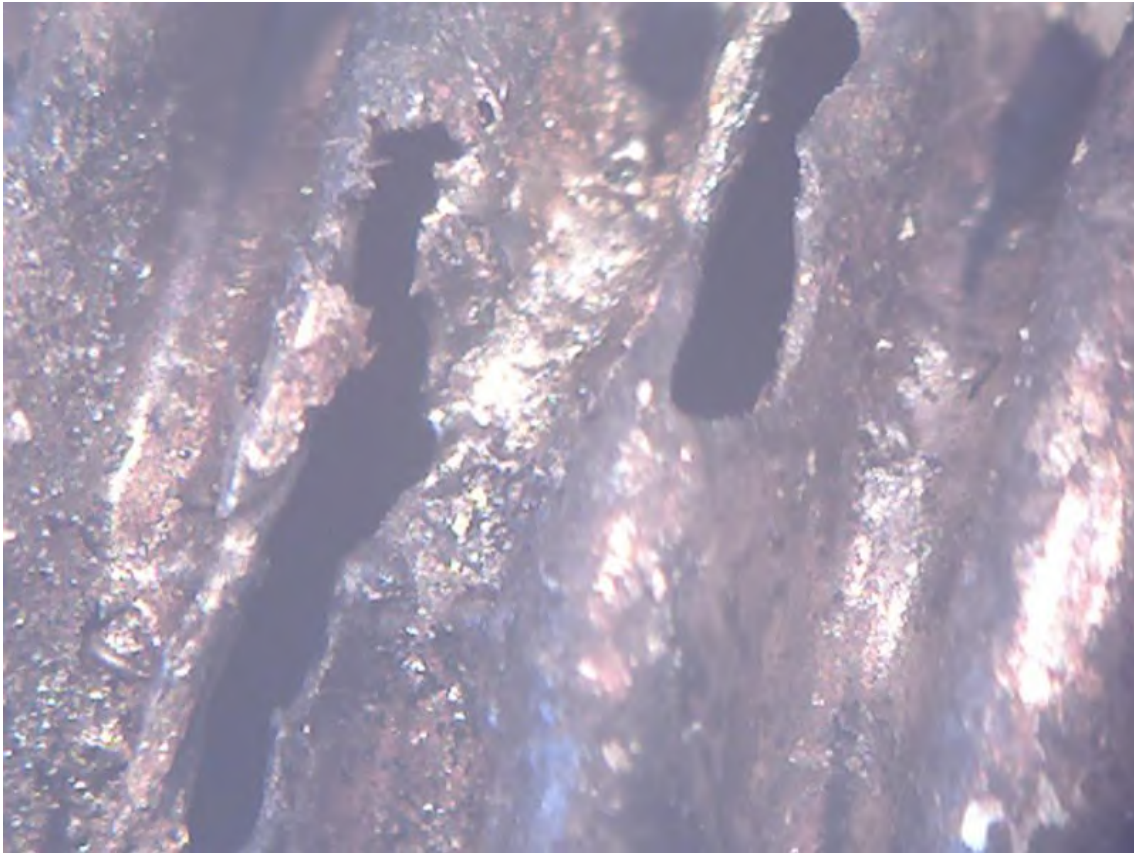
Figure 21. Optical microscope image of the two holes in the flexible gas connector.

There were two holes in the flexible gas connector in the bottom compartment of the fireplace and two holes in the TracPipe CSST line, a larger hole and a smaller hole. All four holes showed evidence of molten and re-solidified metal. As the heat from a typical residential fire is insufficient to melt stainless steel, these holes were all formed by electrical arcing.

The two holes in the flexible gas connector and the smaller hole in the CSST each required approximately 1 C of charge to form.¹¹ Since the charge necessary to form the hole is lower than the total charge delivered by the lightning strike (approximately 4.1 C, as described above), the holes could have been caused by lightning. However, the larger hole in the CSST required approximately 24.9 C to form, or about 6 times the total charge delivered by the lightning strike. Thus, the larger hole could not have been caused by lightning.

Mr. Gerard reported seeing flames in front of the fireplace that were a foot and a half in length very soon after hearing the lightning strike.¹² This observation indicates that gas leaking from the holes in the flexible gas connector was burning soon after the lightning strike, which indicates that the holes were caused by electrical energy from the lightning strike.

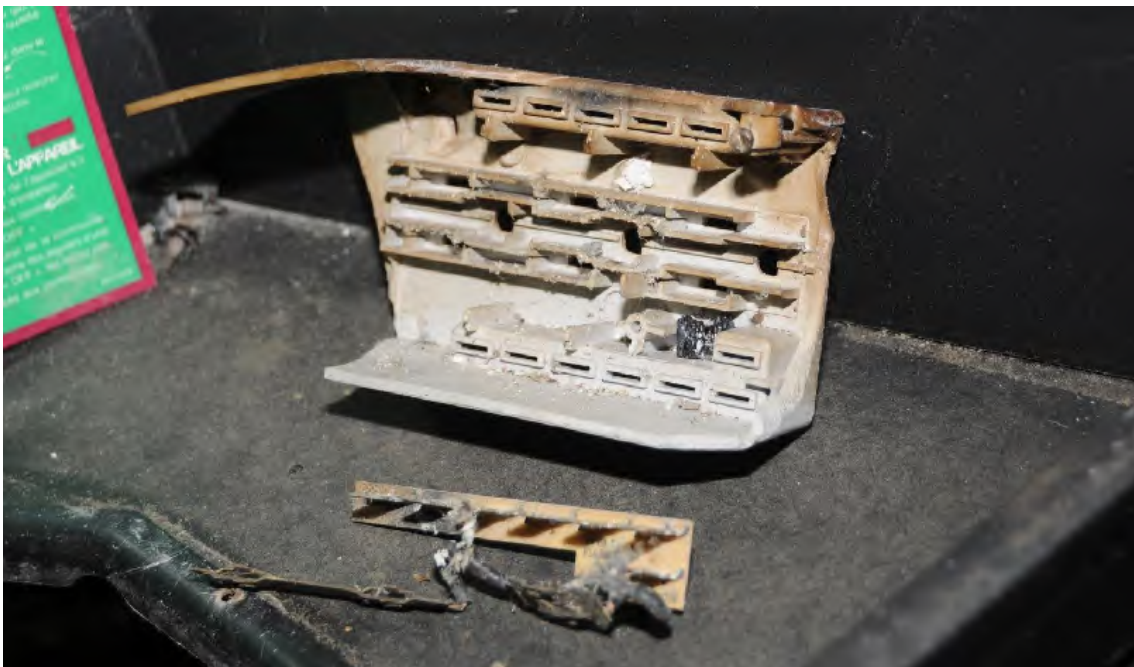
In addition to the damage to the flexible gas connector, there was also damage to an electrical connector in the lower compartment of the fireplace, shown in Figure 22.

Figure 22. Photograph of the damaged electrical connector located in the lower compartment of the fireplace.

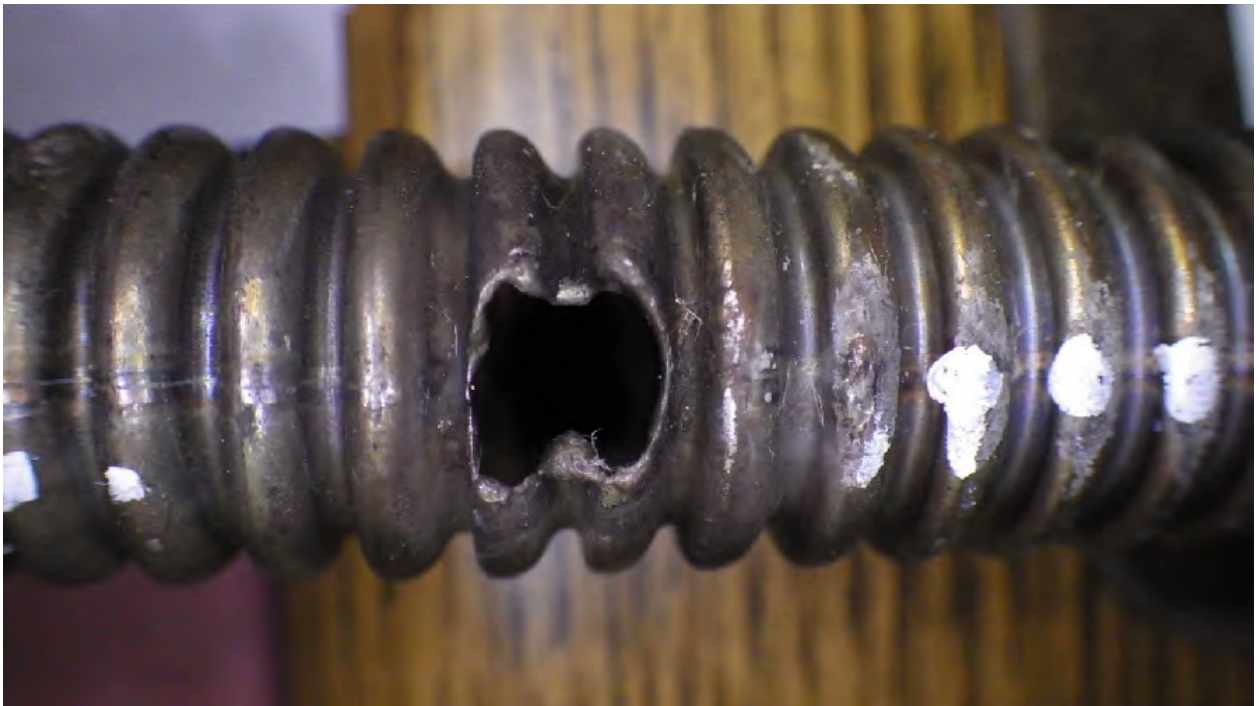
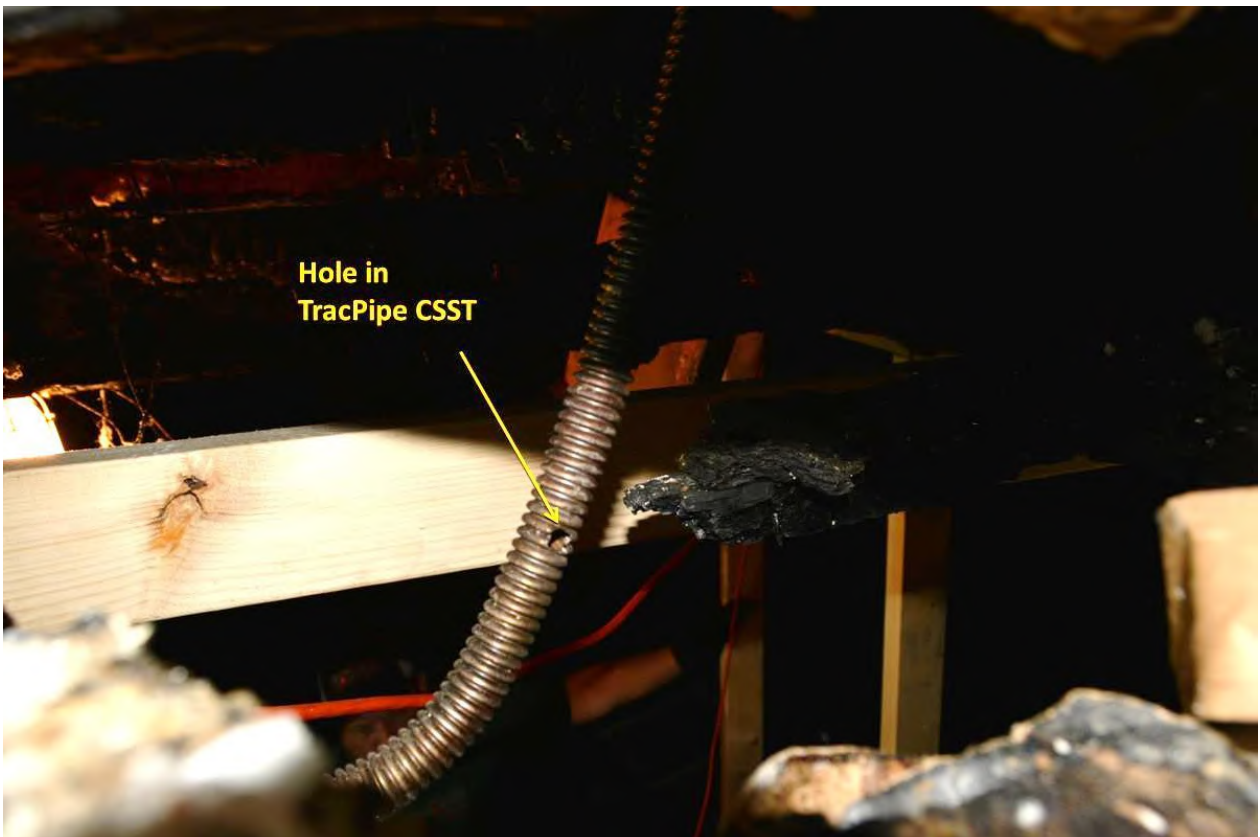
The CSST line to the living room fireplace was ½” diameter nominal TracPipe. Two holes were identified in the TracPipe CSST line: a larger hole (Figure 23) and a smaller hole (Figure 24). The larger hole was 1 foot 3 inches away from the end of the CSST that connected to the fireplace flexible gas connector, while the smaller hole was 3 feet 1 inch away. The location of the larger hole within the Gerard home is shown in Figure 25. The smaller hole was not identified at the scene examination. The larger hole was approximately rectangular with dimensions of 8 mm x 9 mm, while the smaller hole was approximately elliptical with dimensions of 2 mm x 2 mm. Both holes had molten and resolidified metal around the edge of the hole indicating that they were formed by electrical arcing.

Figure 23. Photograph of the larger hole in the TracPipe CSST.

Figure 25. Photograph of the location of the larger hole in the TracPipe CSST.

As described above, the larger hole in the TracPipe CSST could not have been caused by lightning, thus it must have been caused by electrical energy from the household electrical system. There was a hole caused by electrical arcing in the HVAC duct in close proximity to the larger hole in the CSST (see Figure 8 above). The duct may have become energized by contact with a branch circuit wire during the fire and then arced to the CSST. It is also possible that both the hole in the CSST and the hole in the HVAC duct were caused by separate arcing events involving the household electrical system. The duct, branch circuit wires, and CSST were displaced during the fire and the subsequent firefighting efforts, thus their configuration at the time of the scene inspection does not necessarily reflect their configuration prior to the fire.

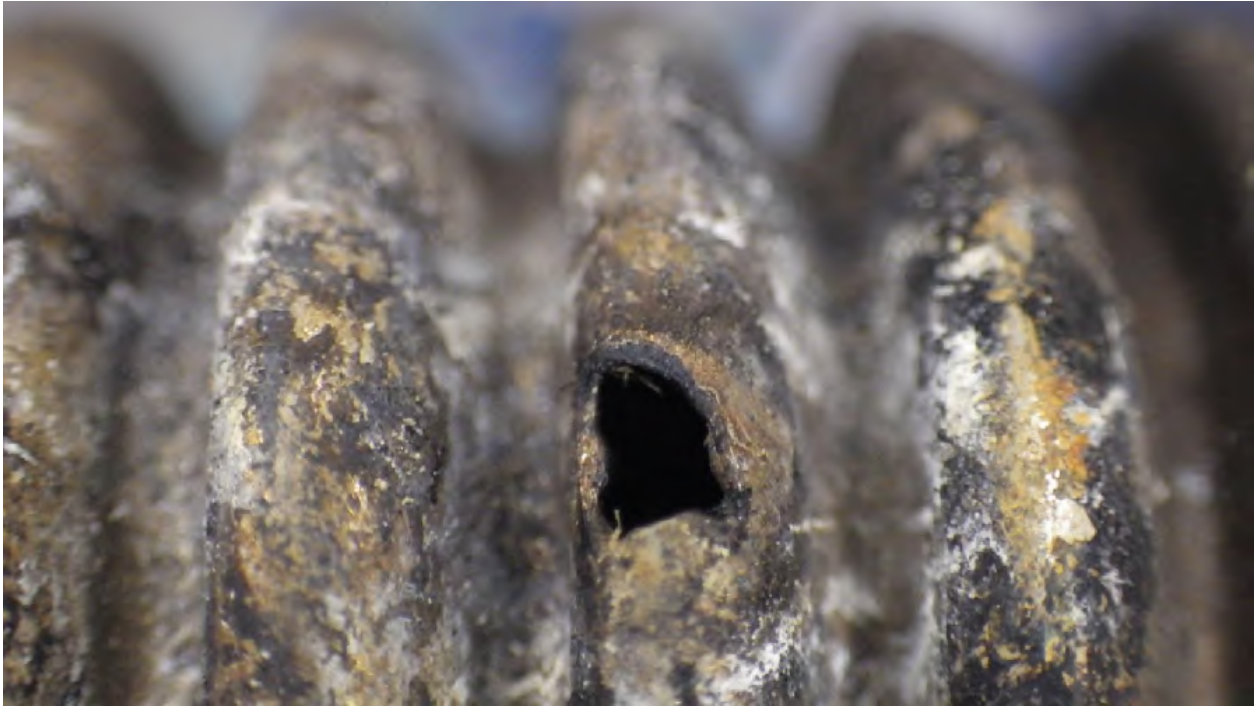
Figure 24. Photograph of the smaller hole in the TracPipe CSST.

The smaller hole in the TracPipe could have been caused by electrical energy from the household electrical system or by electrical energy from the lightning strike. The opposing electrode for the arcing event could have been a branch circuit wire or the HVAC duct.
